Intel[®] Pentium[®] III Processor Specification Update

Release Date: October 2002

Document Number: 244453-045

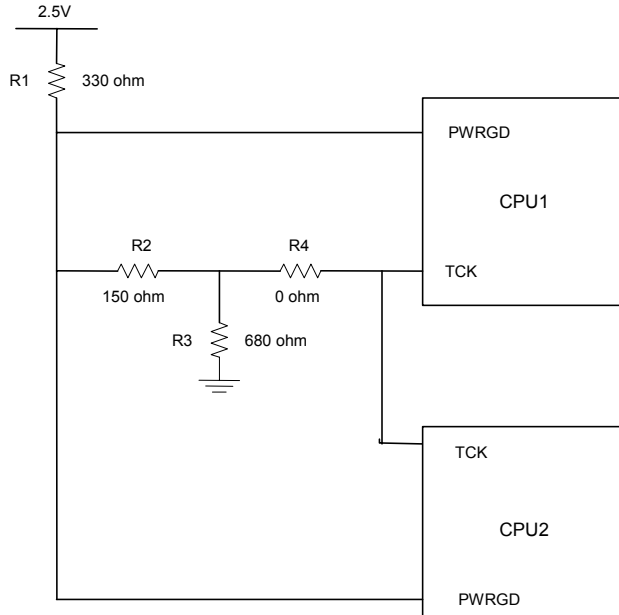
Pentium® III Processor with 512KB L2 Cache Platforms Workaround

Assumes the inputs to the CPU_PWRGD are open collector signals that are Wire-ANDed together

- The example workaround circuit assumes that the PWRGD inputs into the processors are open collector. Tying the PWRGD inputs together in a Wired-AND fashion allows each processor to receive PWRGD at the same time but at the latter of the 2 separate PWRGD assertions. If separation of the PWRGD inputs to each processor is required, extra circuitry will be required.
